Project 677069.00
31 May 2019
R.002.docx
SDH:BWE

Geotechnical Inspections and Testing
Proposed Subdivision
Harmony Estate - Display Village Stage 2, Palmview

1. Introduction

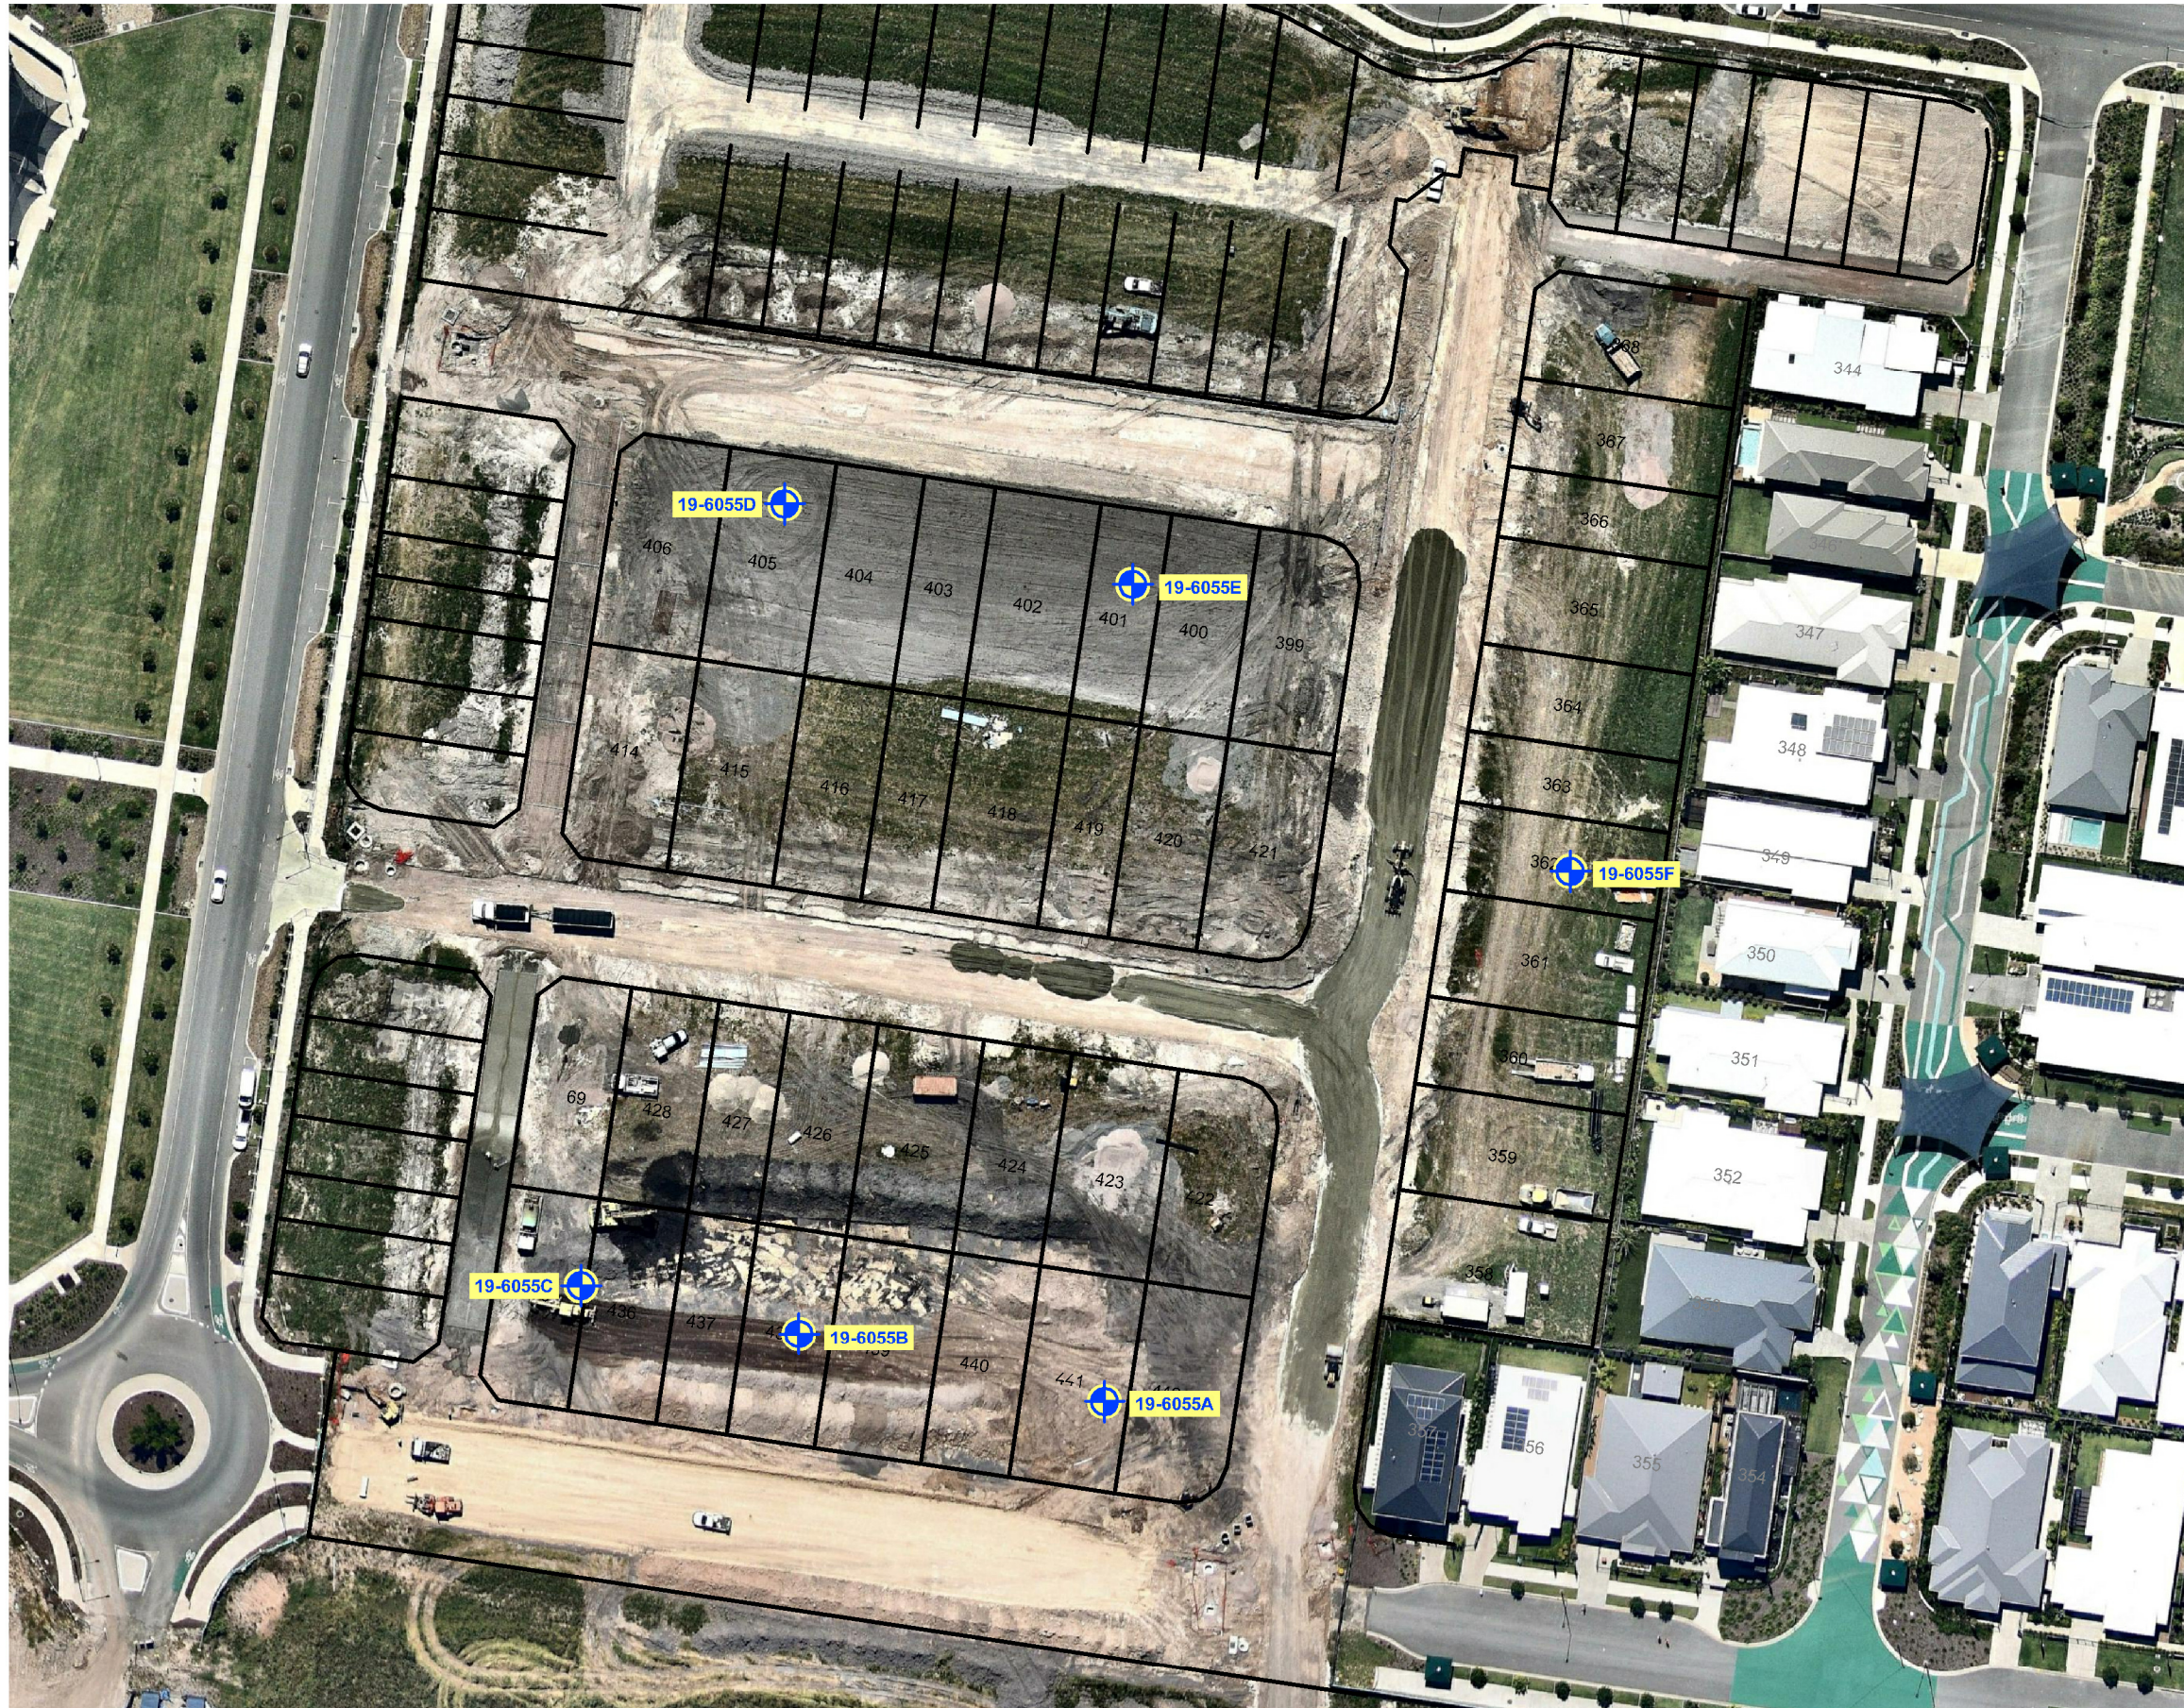
Location Plan

The extent of filling placed at the development over the period 21 March 2019 to 30 May 2019, as covered by this report is shown by the test locations (including elevation) noted on the test report sheets and test location plan attached to this report. This report covers filling placed on Lots 69, 70, 358 to 368, 399 to 406, 414 to 428 and 436 to 442. Any other part of the site is not covered by this report unless stated otherwise.
